# **Stirling Burgh Wall Project, 2024**

## **Data Structure Report (Draft)**

# **Stirling Burgh Wall Project 2024**

## **Data Structure Report**

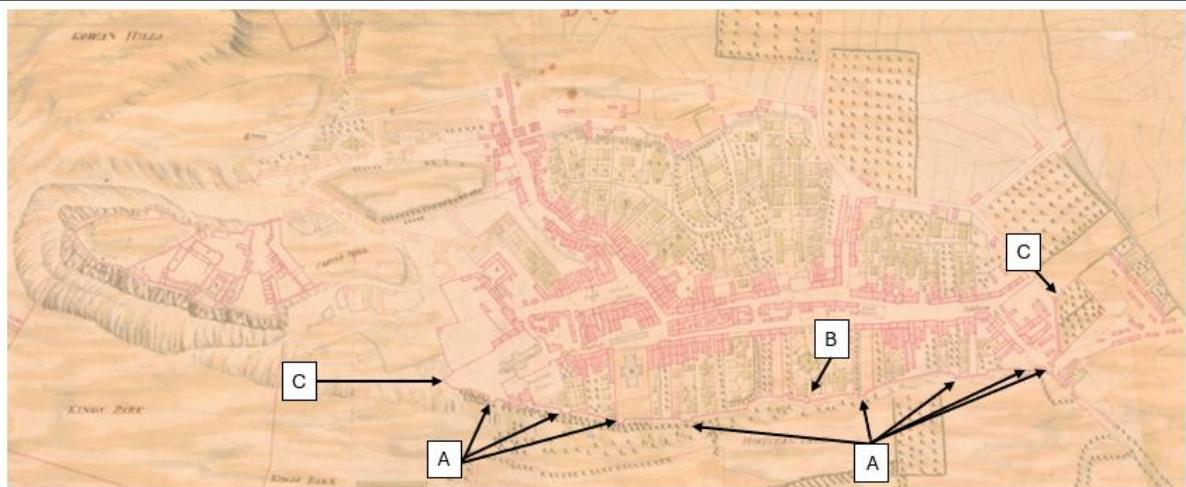
**Figure 2:** Board of Ordnance. Produced in 1760 from a pre 1708 survey. 'Town, Castle and surrounding lands at the attack of the rebels, 1746.' Image from the National Archives, Kew.

**Comments:**

- A. Seven rectangular bastions shown to protrude from wall
- B. Watch tower shown in what is now Allan's Primary School
- C. Wall stops at Lady's rock and turns north-east towards Mars Wark
- D. Thistle Street Round Bastion

The new trench was targeted east of Trench 2 based on historical cartographic evidence, suggesting a rectangular bastion's potential presence in this area (Figure 2). The trench, measuring 4m by 5m, was excavated to a maximum depth of 60cm in the northwest corner of the bastion. On the cemetery side of the wire fence, context [301] was excavated to a maximum of 30cm before stopping due to the frequent occurrence of human bone. Over the wire fence, the bastion was excavated through 20cm of soil [302] and approximately 30cm into [303]. These fully exposed dolerite blocks [305] formed the bastion's walls. Similarly, the joint of the bastion to the city wall (Kirkyard wall) masonry [306] was visible. The masonry in the southwest corner of the bastion was missing. Beneath [303], the remains of a discontinuous cobbled floor [307] were observed, beneath which medium sand with frequent

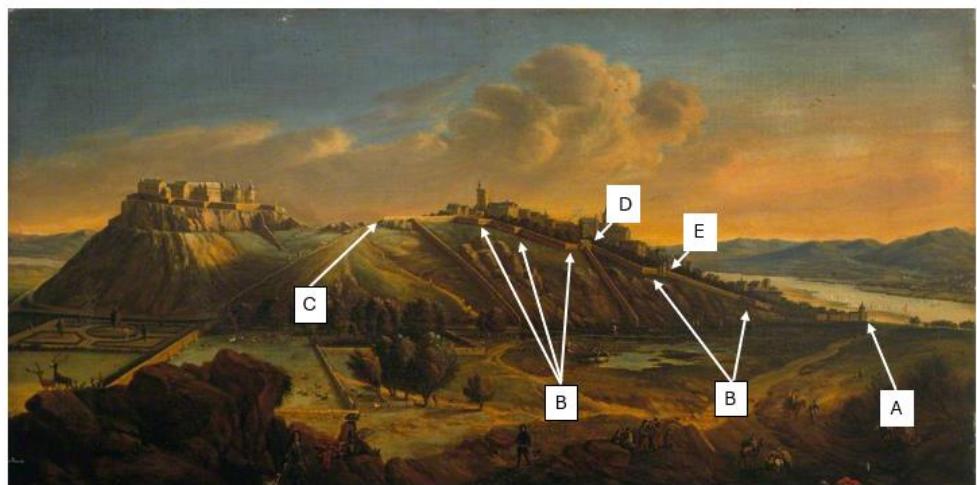
**Figure 3:** Vosterman, Johannes. Produced in 1673. 'Stirling at the time of the Stuarts'. Image from the Smith Art Gallery & Museum

**Comments:**

- A. Thistle Street bastion
- B. Wall is demarcated by angular sections
- C. Wall terminates at Lady's rock
- D. Unknown building within the structure of the wall
- E. Bastion at Allans Primary School

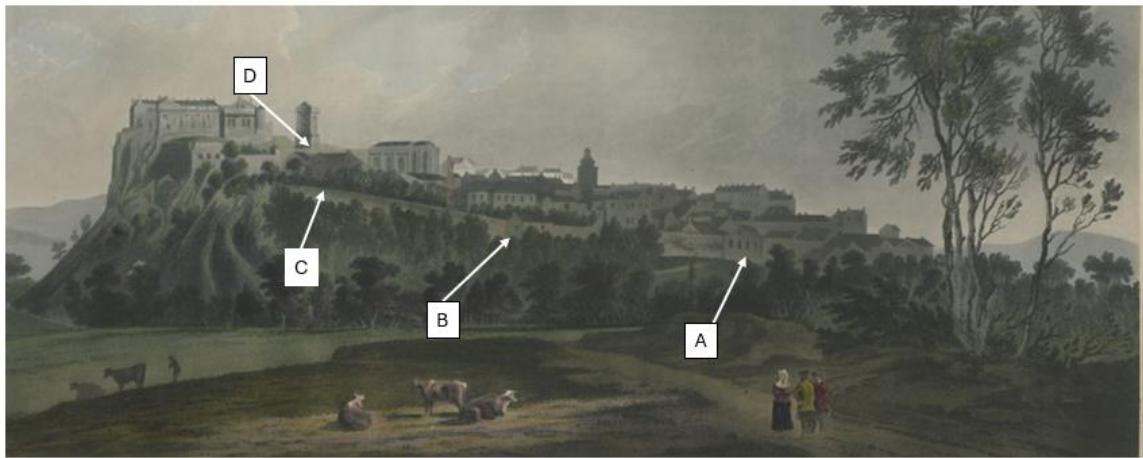
**Figure 4:** Farington, J. 'View of the Town and Castle of Stirling, taken at St Ninians's'. Date 1792.  
Image from British Library

**Comments:**

- A. Round bastion at Allan's Primary School
- B. Unknown building built within the fabric of the wall
- C. Wall continues to Castle
- D. No clear separation between Castle and Burgh

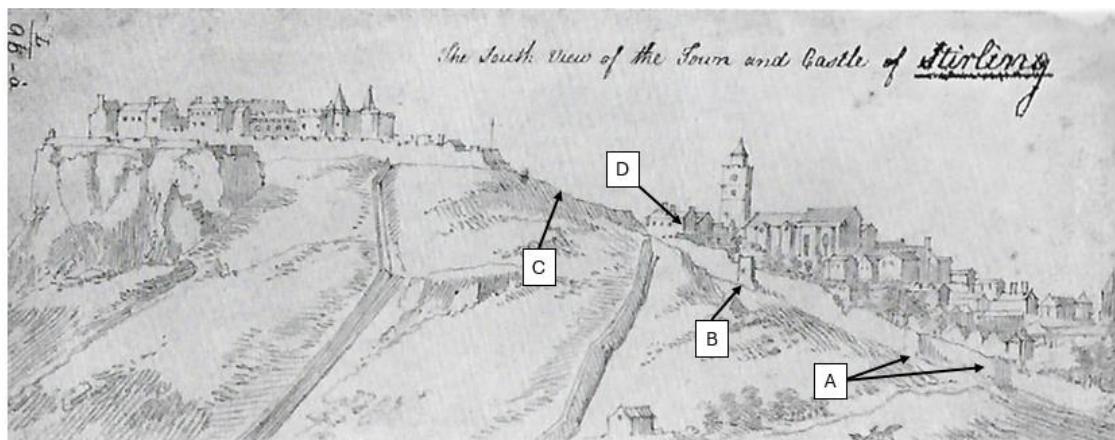
**Figure 5:** Unknown artist and production date. 'The South view of the Town and Castle of Stirling'  
Image from the British Library.

**Comments:**

- A. Shaded relief may suggest angular wall
- B. Unknown building built within the fabric of the wall
- C. Clear separation between Castle and Burgh
- D. Wall appears to terminate in the church yard, adjacent to the Church of the Holy Rude.

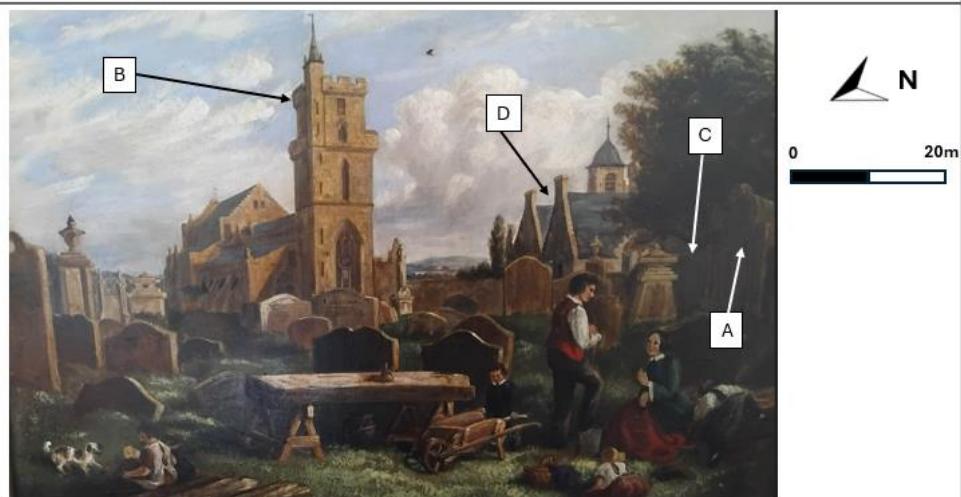
**Figure 6:** Mitchell, Robert. d1845. 'Kirkyard beside Scone MacCulloch Monument'. Image from John Harrison.

**Comments:**

- A. Scone / MacCulloch Monument
- B. Church of Holy Rude
- C. Kirkyard Dyke
- D. Cowan's Hospital

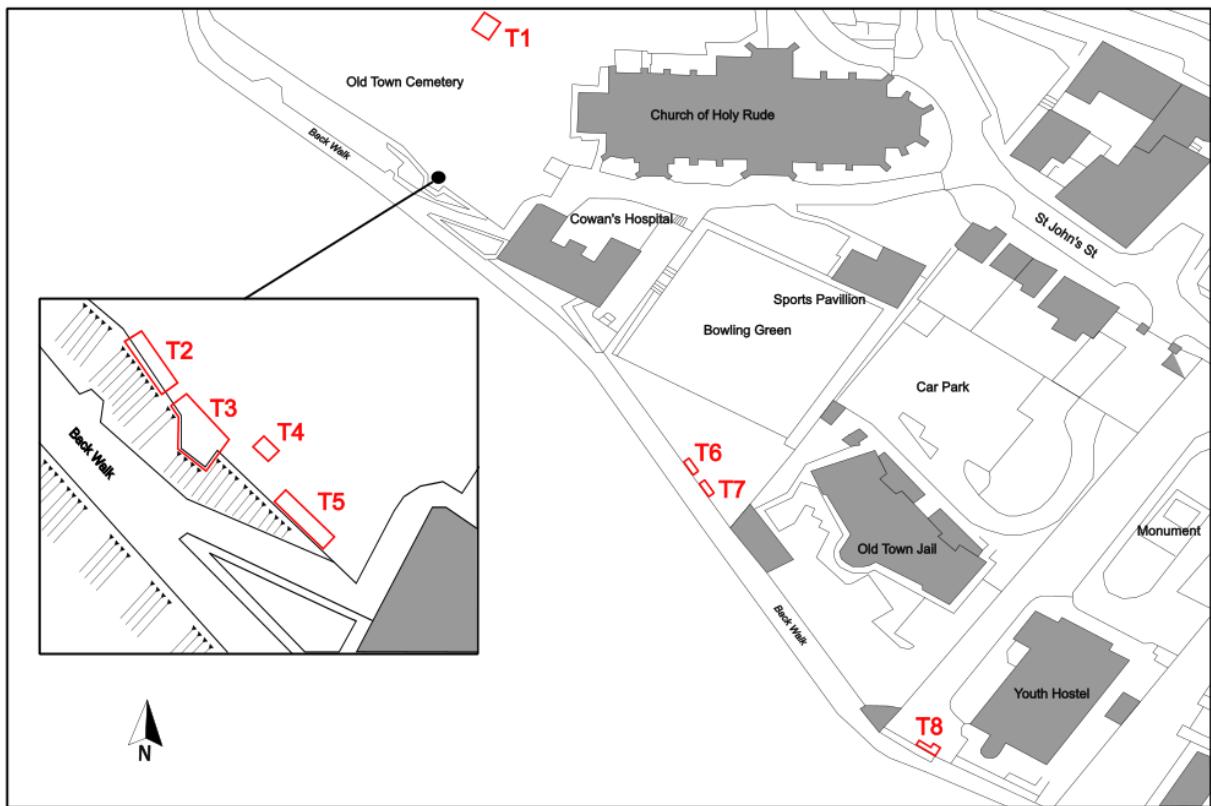
Figure 7 – Trench Locations (Not to Scale). Image from Author.

**5.4.** Due to the fragmented nature of the surviving remains and the challenges posed by modern encroachment, excavation opportunities were limited to four areas involving eight trenches, as illustrated in Figure 7. Two of these areas are on private land, while the other two are on land managed by Stirling Council. An additional complication arose as one location (T8) lies within the scheduled area of 'Stirling Town Wall and Bastion, and Port Street Bastion at 44 Bastion Wynd (SM1754)'. Consequently, in addition to obtaining consent from landowners and Stirling Council, scheduled monument consent was also sought and granted by Historic Environment Scotland.

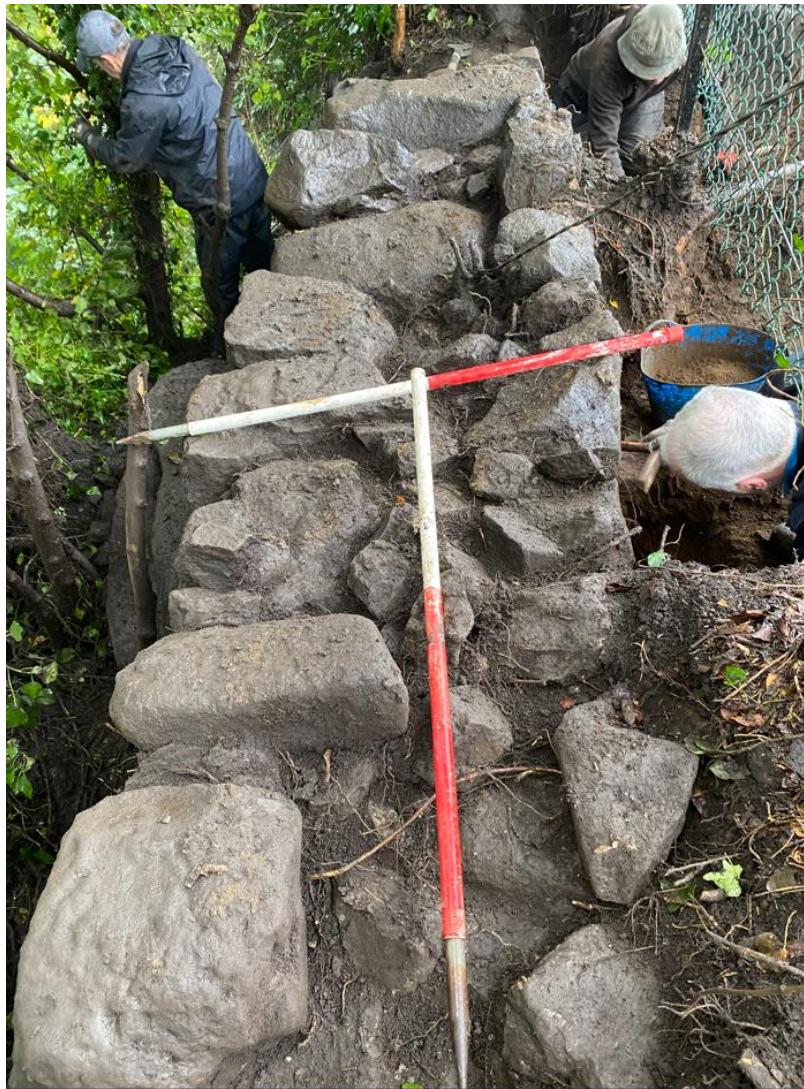
**Figure 8:** Trench 2: Volunteers cleaning in Trench 2 on the outward side of the wire fence adjacent to the cliff edge. Taken looking west towards Ladies Rock. Image from Author

human inhumations—a clear sign of the intensive use of the cemetery over successive centuries. No significant findings were made within this section, prompting an extension of the trench by an additional metre beyond the wire fence to the cliff edge overlooking the Back Walk. This extension uncovered a 3m truncated stone walling bonded with lime mortar [203]. The stone, all of dolerite, varied in size, up to 30cm by 15cm by 15cm. The revealed section, measuring approximately 3m long and averaging 80cm in thickness (see Figure 8), was interpreted as part of the 16th-century city wall.

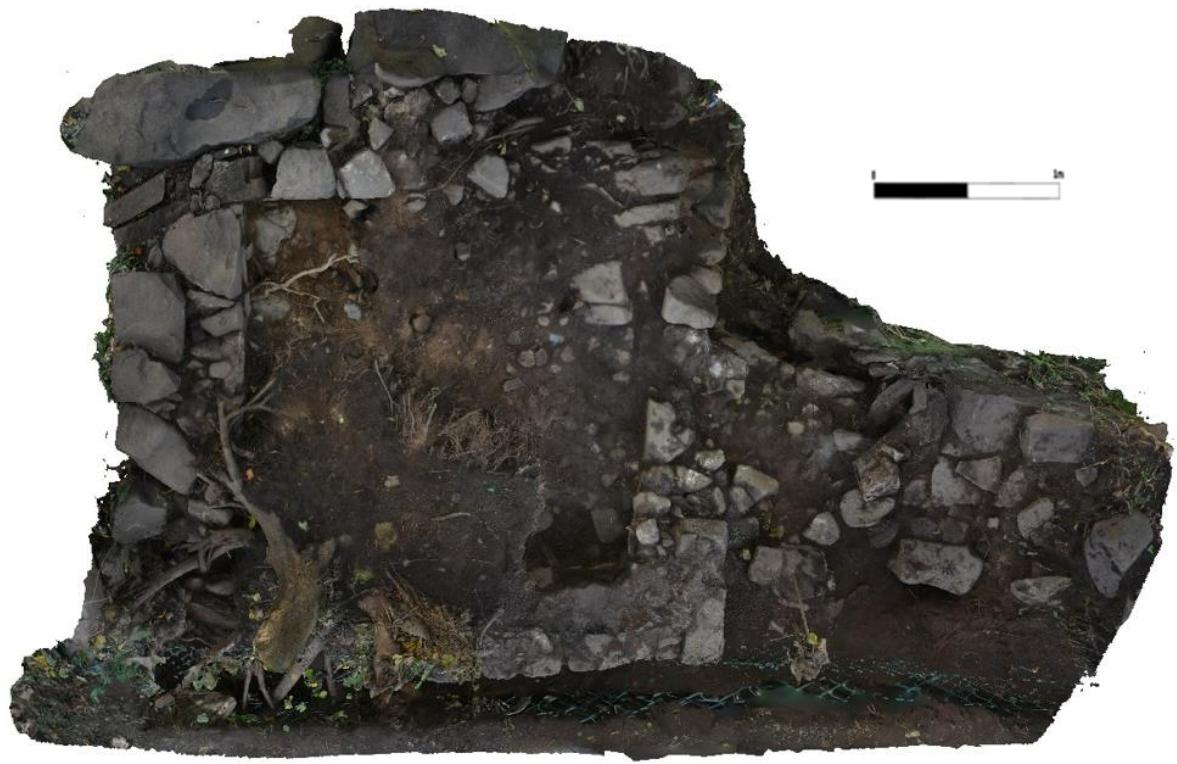
**Figure 10** – Photogrammetry plan of excavated and previously unrecorded bastion and burgh wall section in Trench 3 - orientated south and adjacent to the Old Town Cemetery, Stirling. Image from Author.

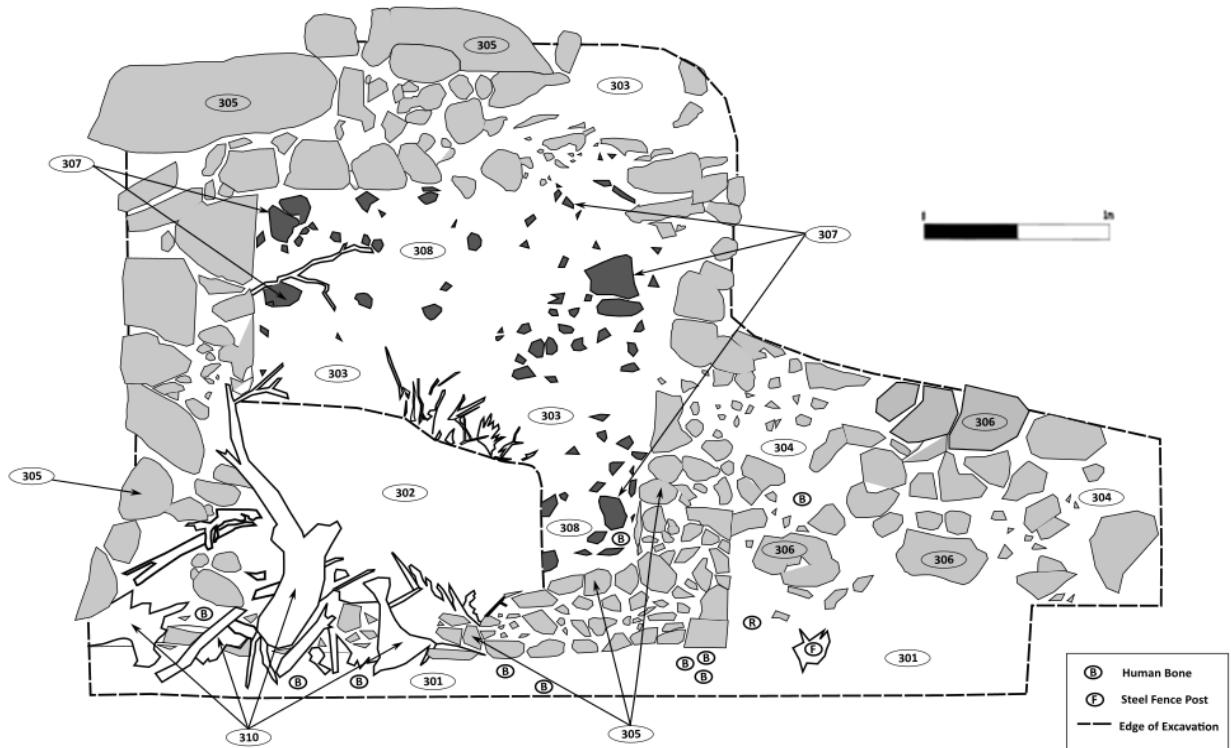
**Figure 11** – Plan of Bastion in Trench 3, oriented south. Image from Author.

**10.2.** The bastion, composed of a natural dolerite outcrop reinforced with masonry, occupies a commanding position overlooking the southern approach to Stirling. Artefacts such as 16th- and 17th-century Flemish floor tiles and Scottish earthenware ceramics suggest significant investment to ensure its utility and defensive readiness. Excavations in Trench 3 confirm that this bastion was integrated into the broader defensive enceinte, as evidenced by its connection to the perimeter wall and an entrance. This defensive enceinte extended west of Cowan's Hospital, corroborated by discovering a masonry wall and demolished bastion position. However, further westward evidence is likely lost due to 19th-century cemetery modifications.

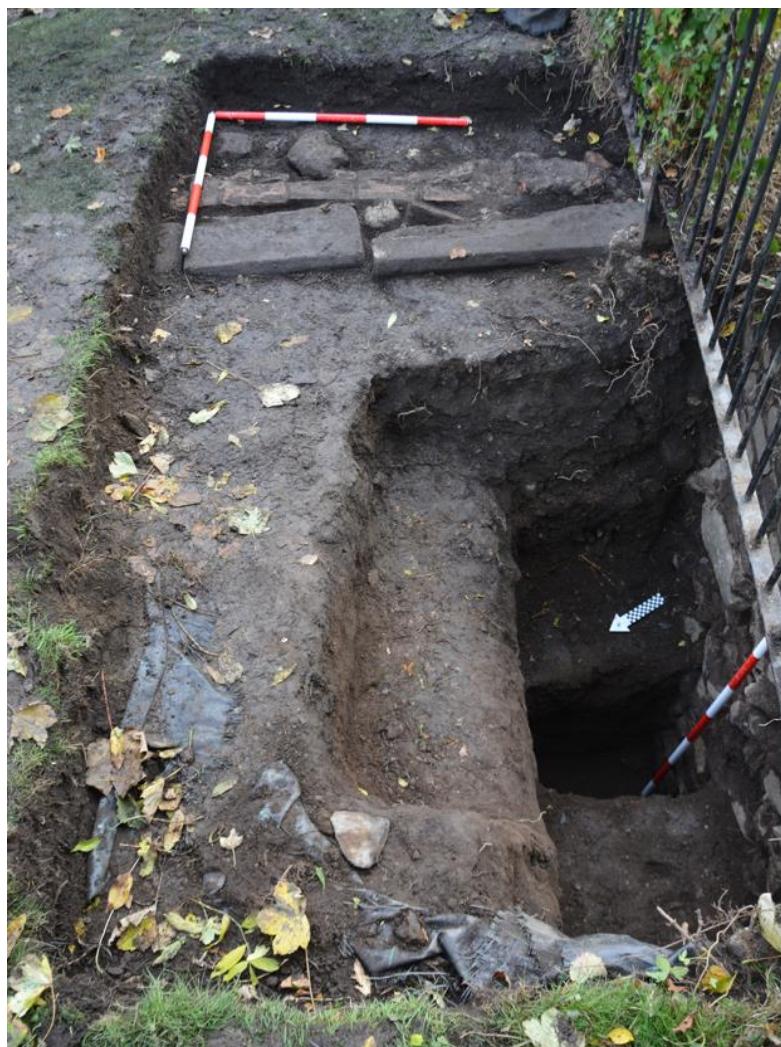
**Figure 12-** Excavation of Trench 5 looking east, showing 18-19<sup>th</sup> century watchtower foundations and boundary and cemetery boundary wall.

Trench 5 was positioned east of Trenches 3 and 4 to examine the extant remains of the Wall located immediately west of Cowan's Hospital. Measuring 4m by 1.5m, the trench was excavated to a depth of 1.83cm at its deepest point through dark silt soil [501]. It revealed a substantial masonry wall section demarcating the boundary between the Old Town Cemetery and the Back Walk, as illustrated in Figure 12. The western side of the trench exposed brickwork foundations associated with an 1820 cemetery watch tower, although these were not fully excavated as they fell outside the scope of the research. A 1m by 1m sondage within Trench 5 was dug to reveal the internal face of the masonry wall, which comprised dolerite and sandstone blocks. The Wall's thickness was measured at 35cm. The findings indicate that this section of the boundary wall is not the original 16th-century defensive town wall but a later, reduced reconstruction that predates the bothy construction in 1820.

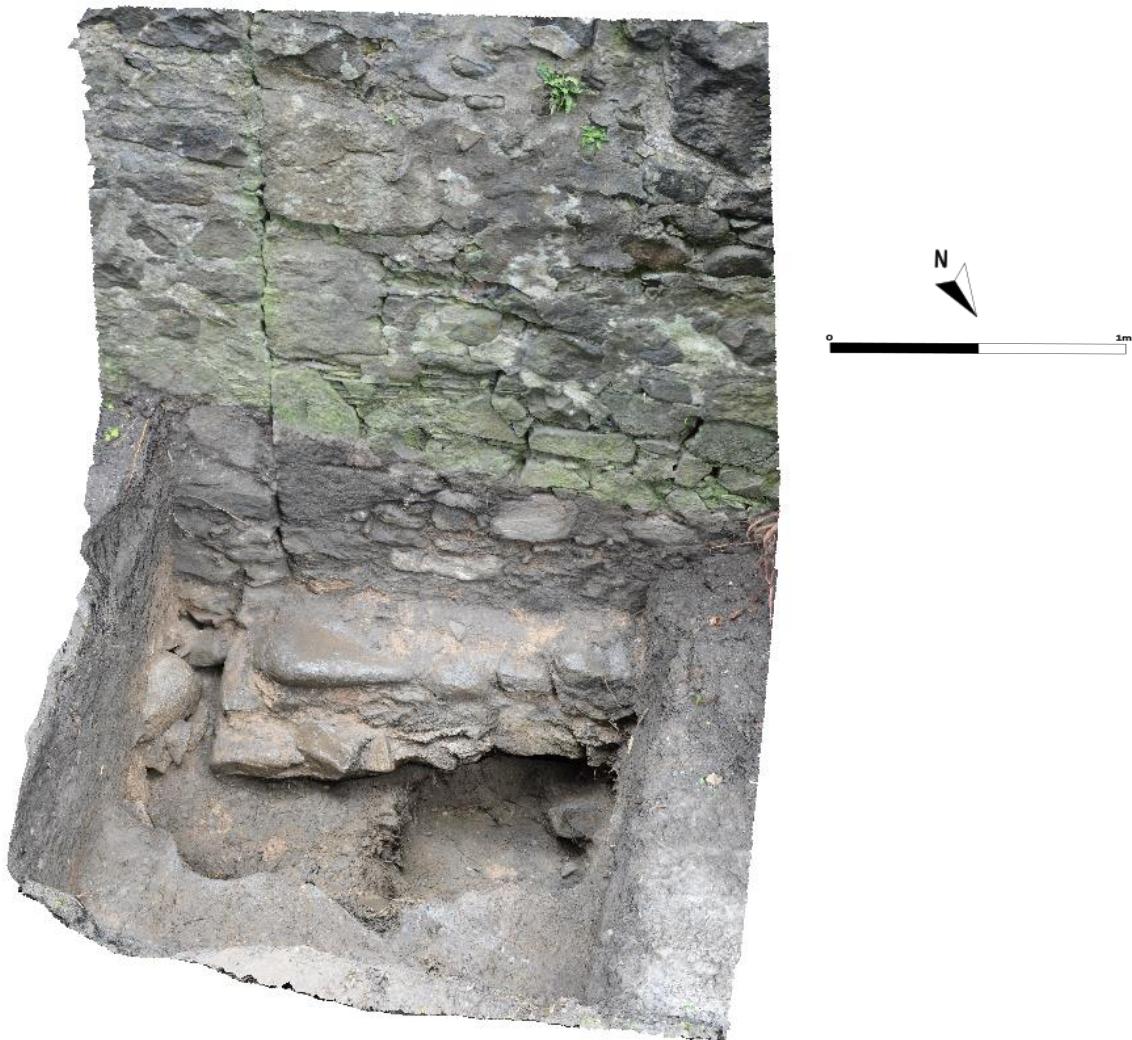
Figure 13 – Photogrammetry of Trench 7. Image from Author

7.8. Trenches 6 and 7 exhibited similarities, though Trench 7 provided additional detail (Figure 13 & 14). Specifically, masonry [704] was identified as a distinct phase and was not integrated with [704], as

depicted in Figure 13. Furthermore, context [707] lacked a visible footing, suggesting its foundations extended deeper than 1m and were separate from [704]. At the base of [707], a second demolition layer [708] was observed, characterised by grey clay silt with sub-angular pebble inclusions, extending 60cm into the parterre garden. Beneath this layer, a random infill of dolerite cobbles with numerous voids was noted. The total depth of this infill could not be ascertained, but it is presumed to extend deeper beyond that which was visible in the trench.

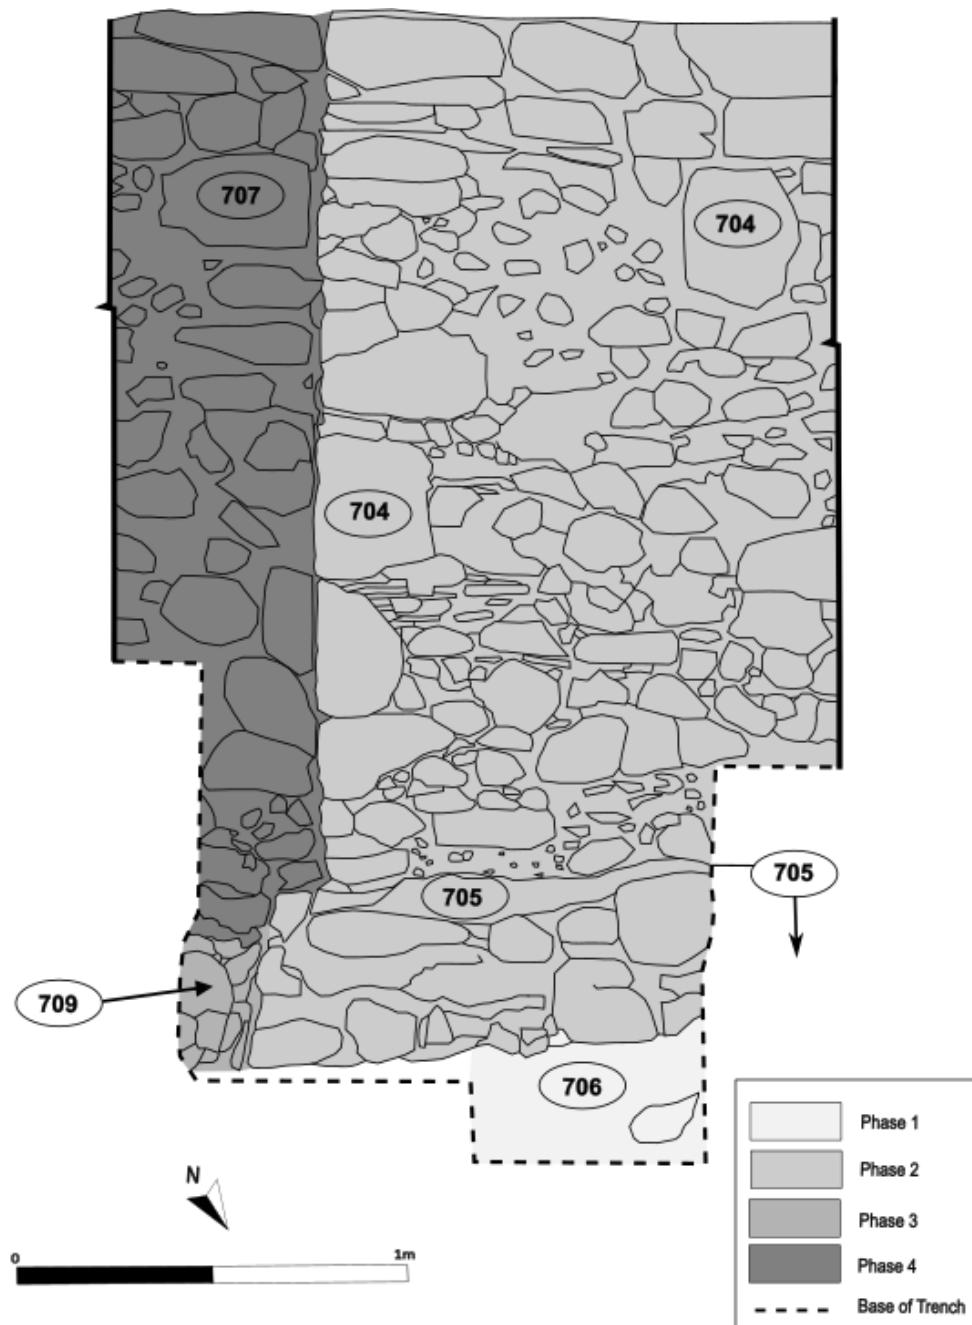
Figure 14 – Elevation Trench 7

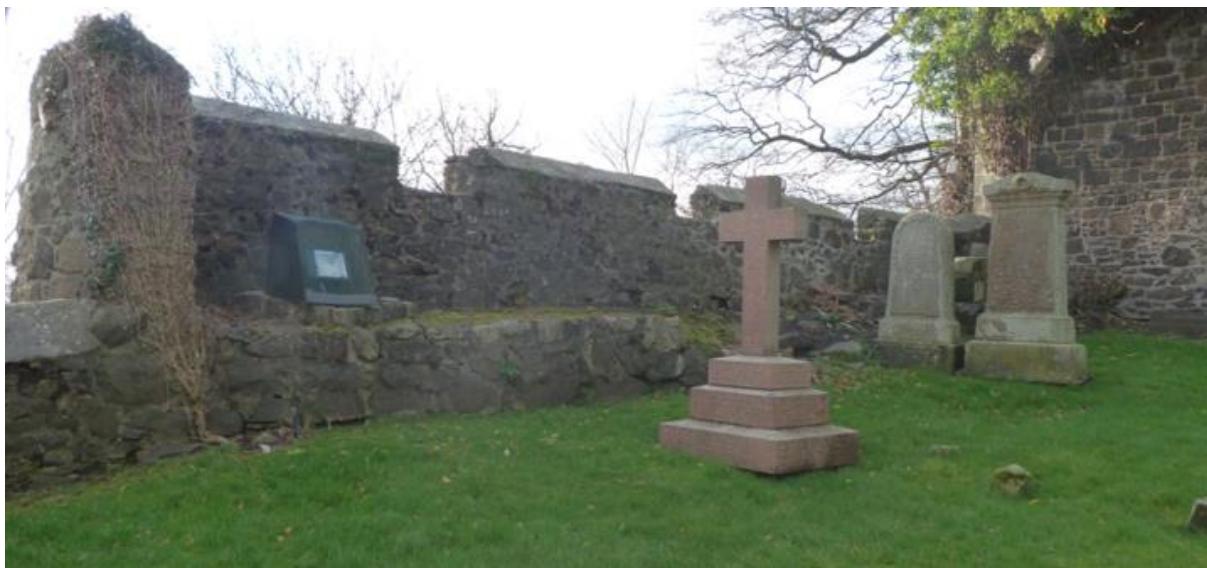
**Figure 15 – Trench 8 location before excavation. Image from Authors**

Located at the rear of Stirling Youth Hostel on St John's Street and within the protected scheduled area of SM1754. Historic Environment Scotland recognises the section of masonry structure to the rear of this property as an original and singularly continuous section of the 16<sup>th</sup>-century town wall. The masonry structure has a parapet and crenellations [808] and comprises random cut dolerite and sandstone blocks, pointed and capped with modern Portland Cement. In the east, it directly adjoins a straight section of the town wall running downhill [809]. In the west, it abuts the boundary wall of the 1847 Old Town Jail, and in the south, the structure separates the Youth Hostel grounds from the Back Walk, acting as a retaining wall to the higher ground level in the Youth Hostel, as shown in Figure 15.

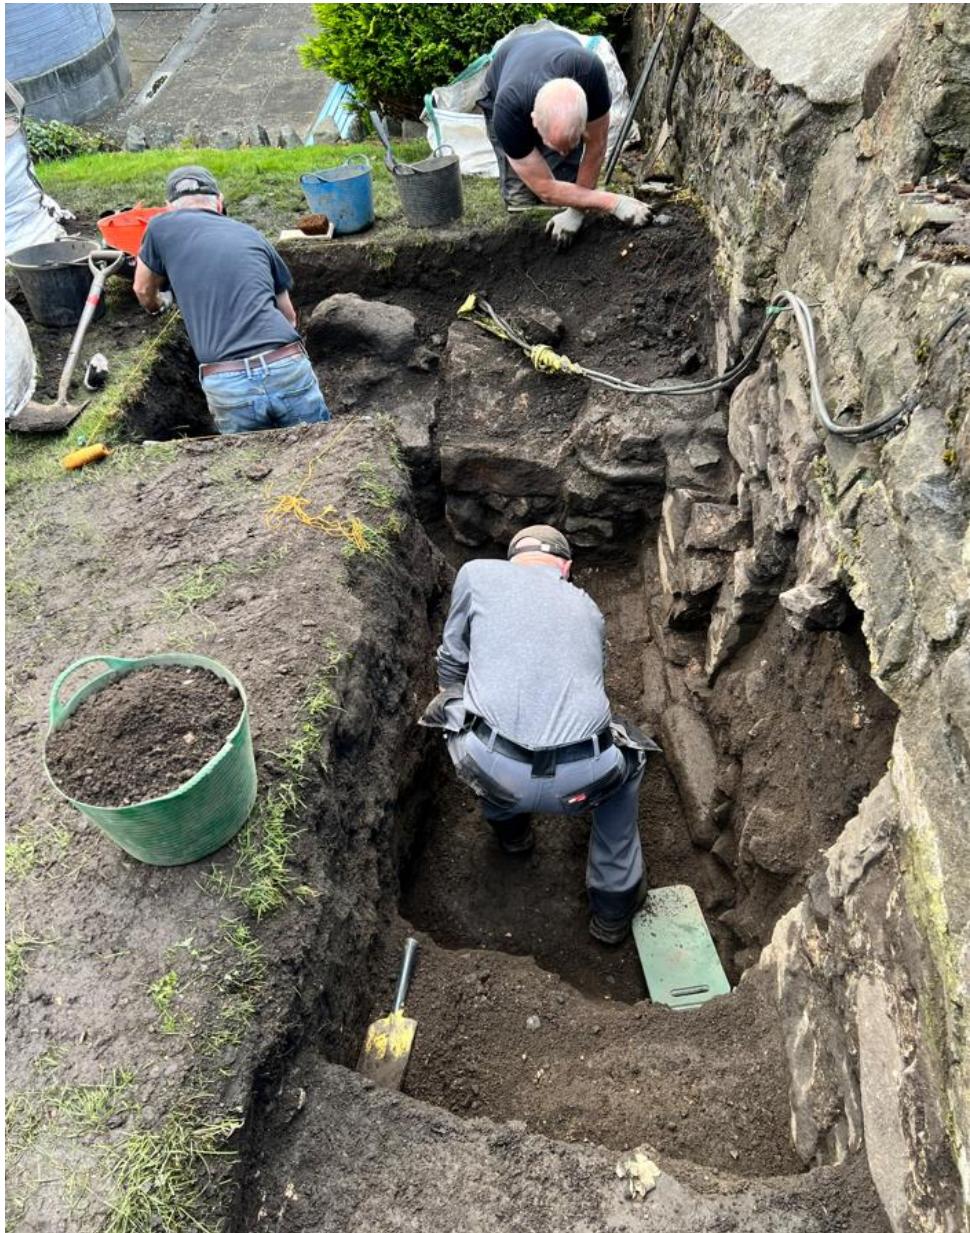
**Figure 16** – Trench 8 under excavation in August 2024. Image from Authors.

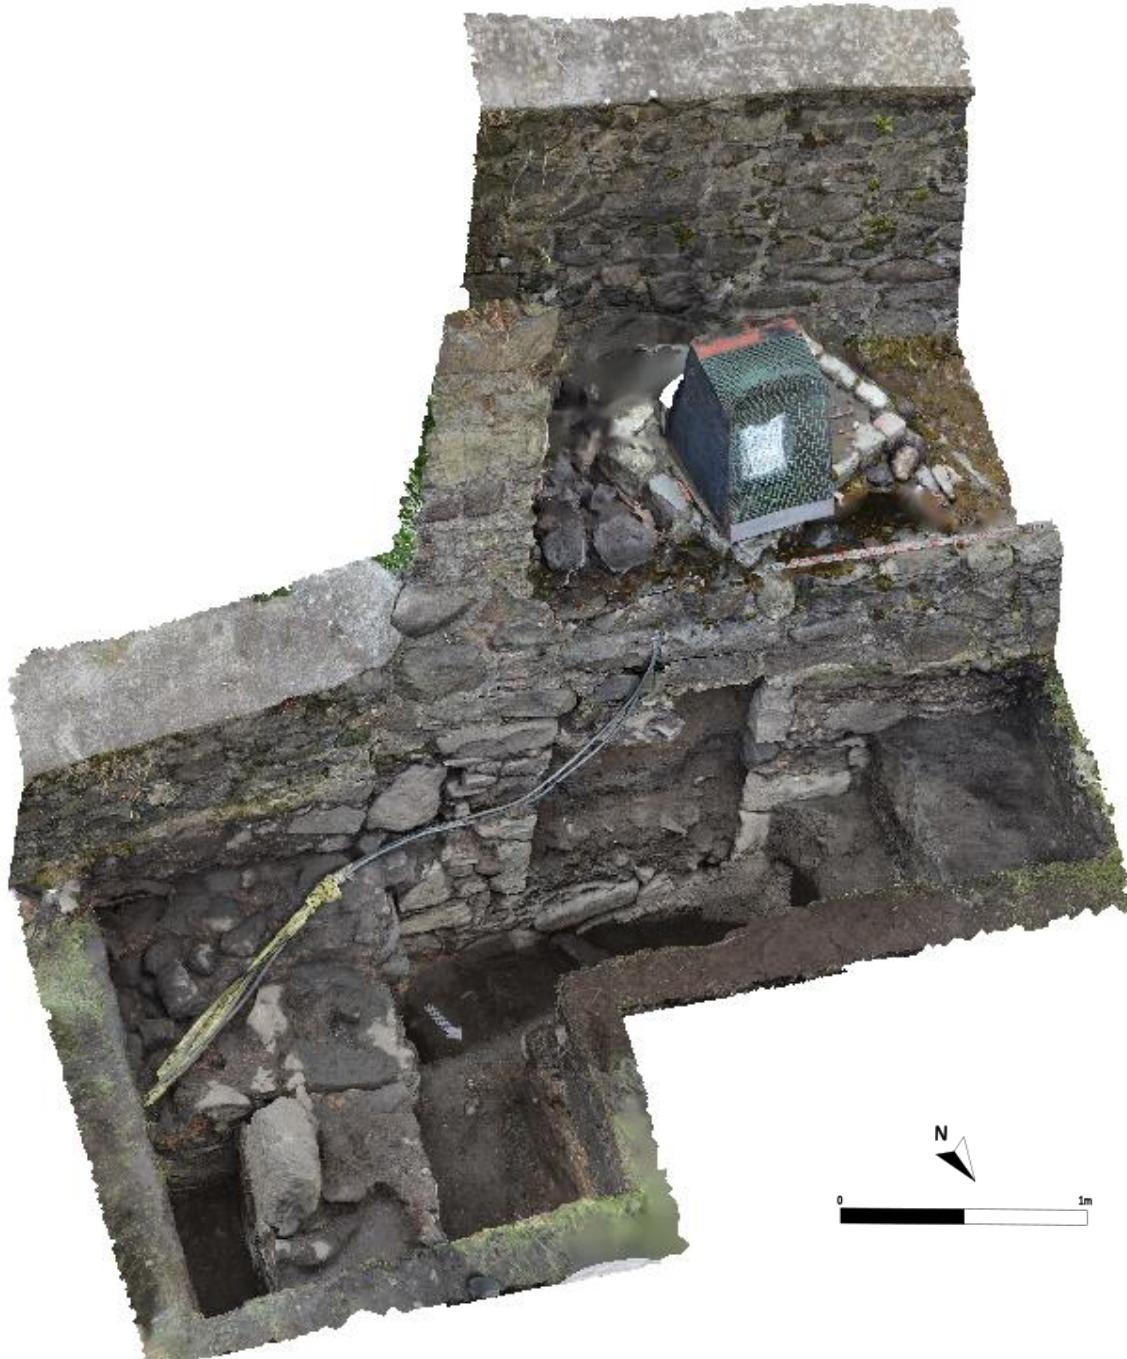
Figure 17 – Photogrammetry of Trench 8. Image from Authors.

7.16. Trench 8 contains significant archaeological remains, revealing multiple phases of construction. The evidence indicates that Structure 1 [806], [807], [809] and [808], represents the initial phase of construction, forming part of a substantial defensive bastion integral to the town's defensive enceinte. This bastion incorporated a covered chamber on its eastern side, providing access to a gun loop designed for defensive flanking fire. The structure's walls are c.1.4 meters thick. The parapet [808] is likely an original feature dating to the 16th century; however, the crenellations are unlikely to be contemporaneous, as crenellated designs are wholly absent elsewhere along the city wall. These features may represent a 19th-century artistic enhancement of the parapet. Significant alterations have occurred at the bastion's western end, where certain sections have been demolished and rebuilt during the jail's construction. Consequently, whether the western elevation originally mirrored the eastern side is unclear but could be the subject of future excavation. Additionally, a larger gun loop is present in the centre of the bastion, facing directly south. Again, this feature, however, was not excavated, as it lay beyond the scope of the current consent.

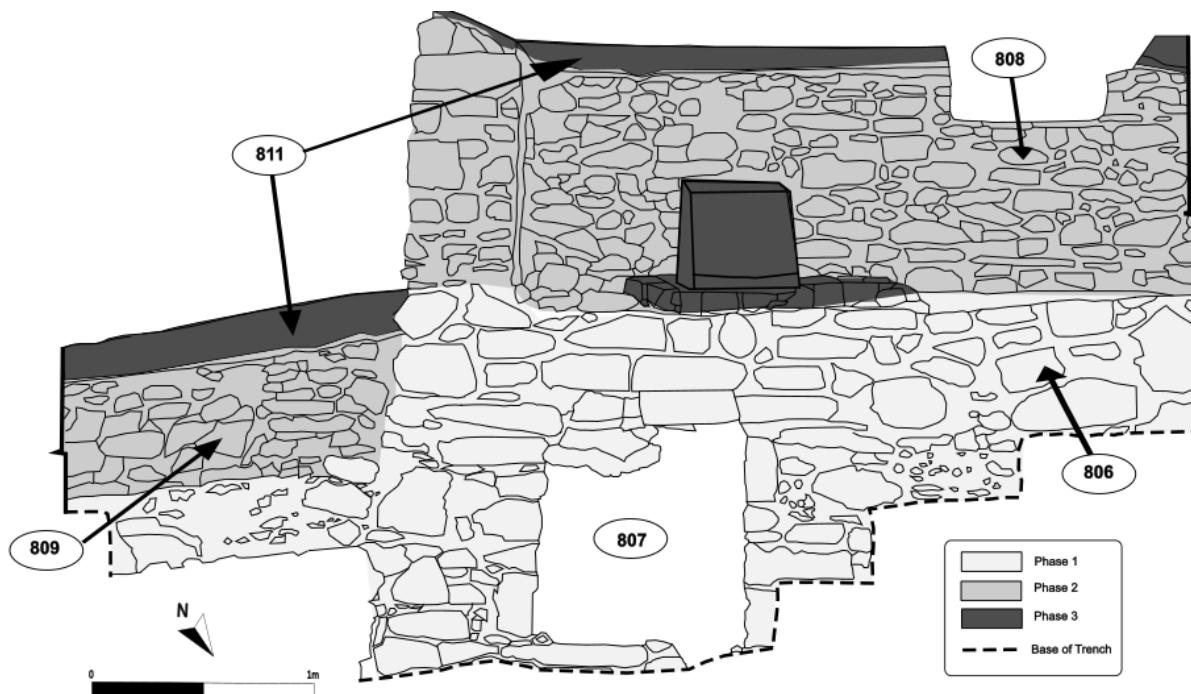
Figure 18 – Section of the bastion at Trench 8 showing multi-phasing. Image from Authors

7.17. In addition, the evidence suggests that a second phase [805] was constructed adjacent to or on top of Structure 1 [806] and ran into the grounds of the Youth Hostel Figure 21. This is likely to be the structure noted in Figures 3,4 and 5.

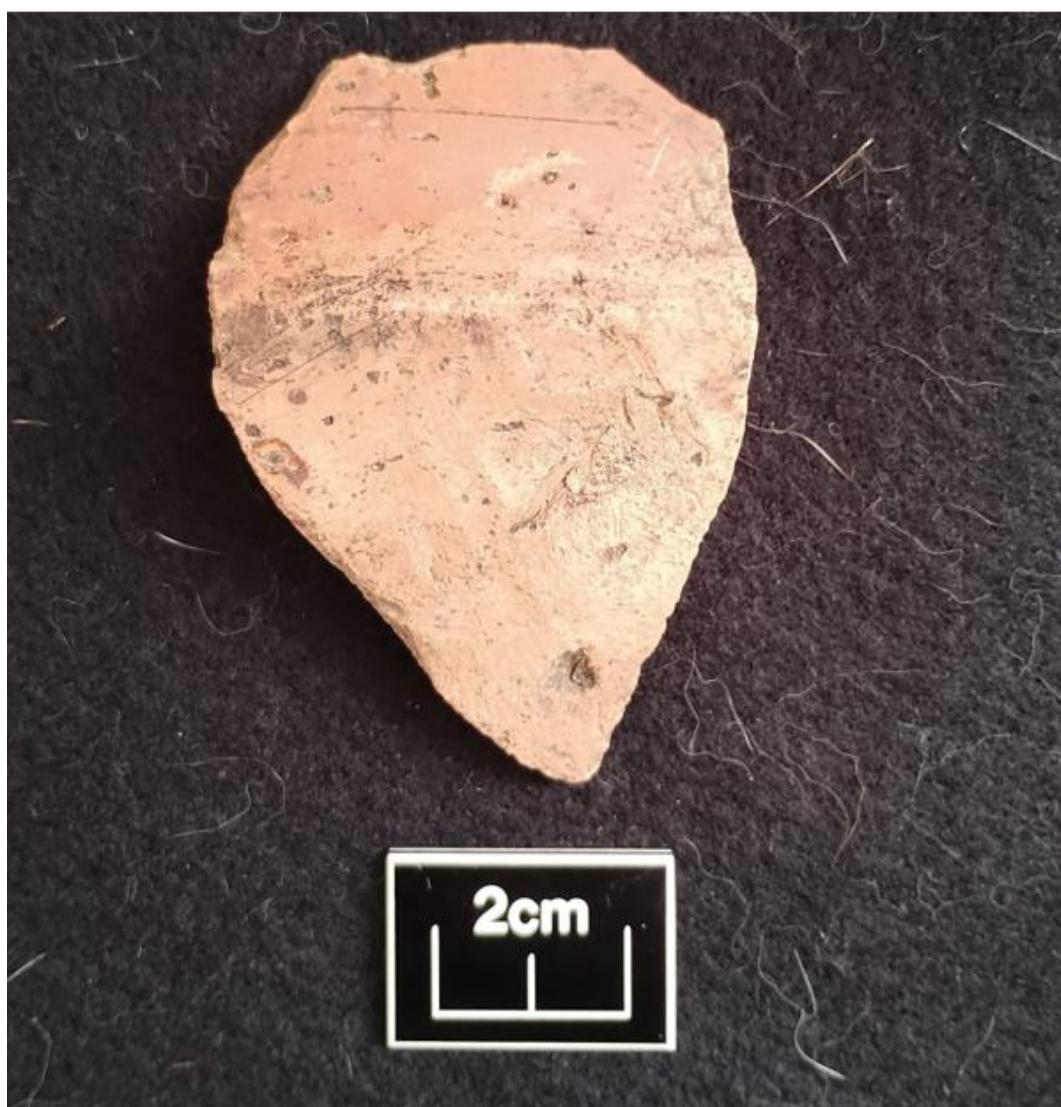
T3 -Context 301 SF1 (Figure 20)

Basal angle in Scottish Redware with oxidised exterior surface and reduced grey core and interior. Tiny flecks of green-brown glaze are visible on its exterior surface. This belongs to the later end of the Scottish Redware industry before the onset of mass-produced vessels in Scottish Post Medieval Oxidised and Reduced Wares (also known as Throsk-Type Wares) (Caldwell and Dean 1992; Harrison 2002; Haggarty, Hall & Cheshire 2011, 13). It potentially dates to the 16<sup>th</sup> / 17<sup>th</sup> centuries.

Figure 20 - Trench 3 Context [301] SF1 Basal angle of Scottish Redware. Image from D. Hall.

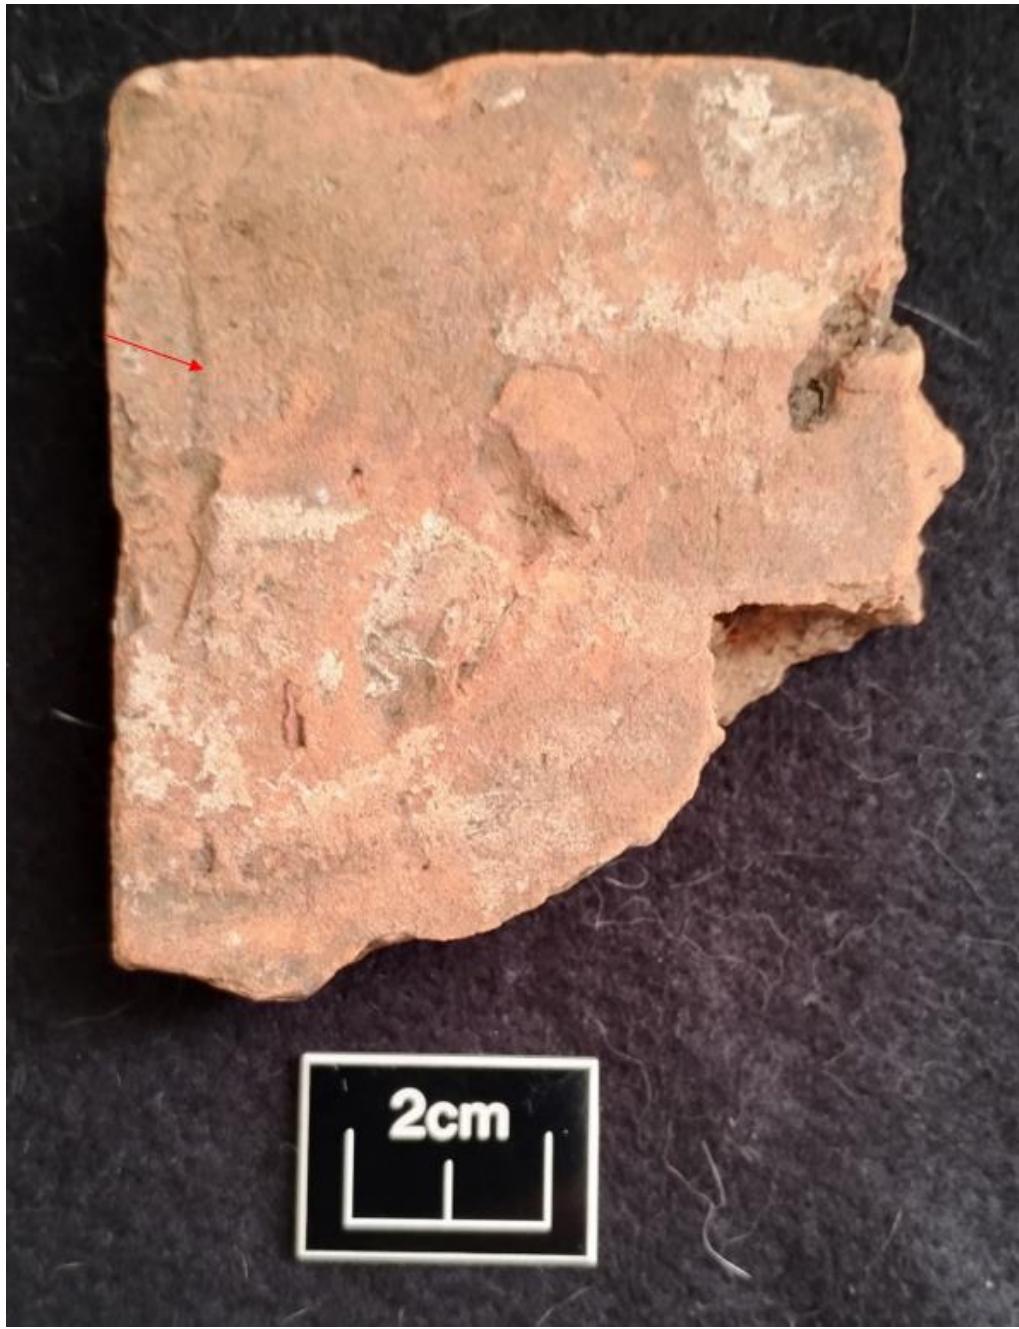
### **8.3. T3 - Context 301 SF2 (Figure 21)**

A corner from a fragment of 2cm thick Redware floor tile that measures 7cm by 8cm has traces of a white slip with tiny flecks of glaze on its edges and surfaces. Its potential upper surface has a visible incised line parallel to one of the edges. The fabric of this tile is very red, and the presence of a white slip makes it highly likely that it is an import from a low country.

**Figure 21** - Trench 3 Context [301] SF2 Corner fragment of white slipped Low Countries floor tile, red arrow indicates incised line running parallel to one of the edges. Image from D. Hall.

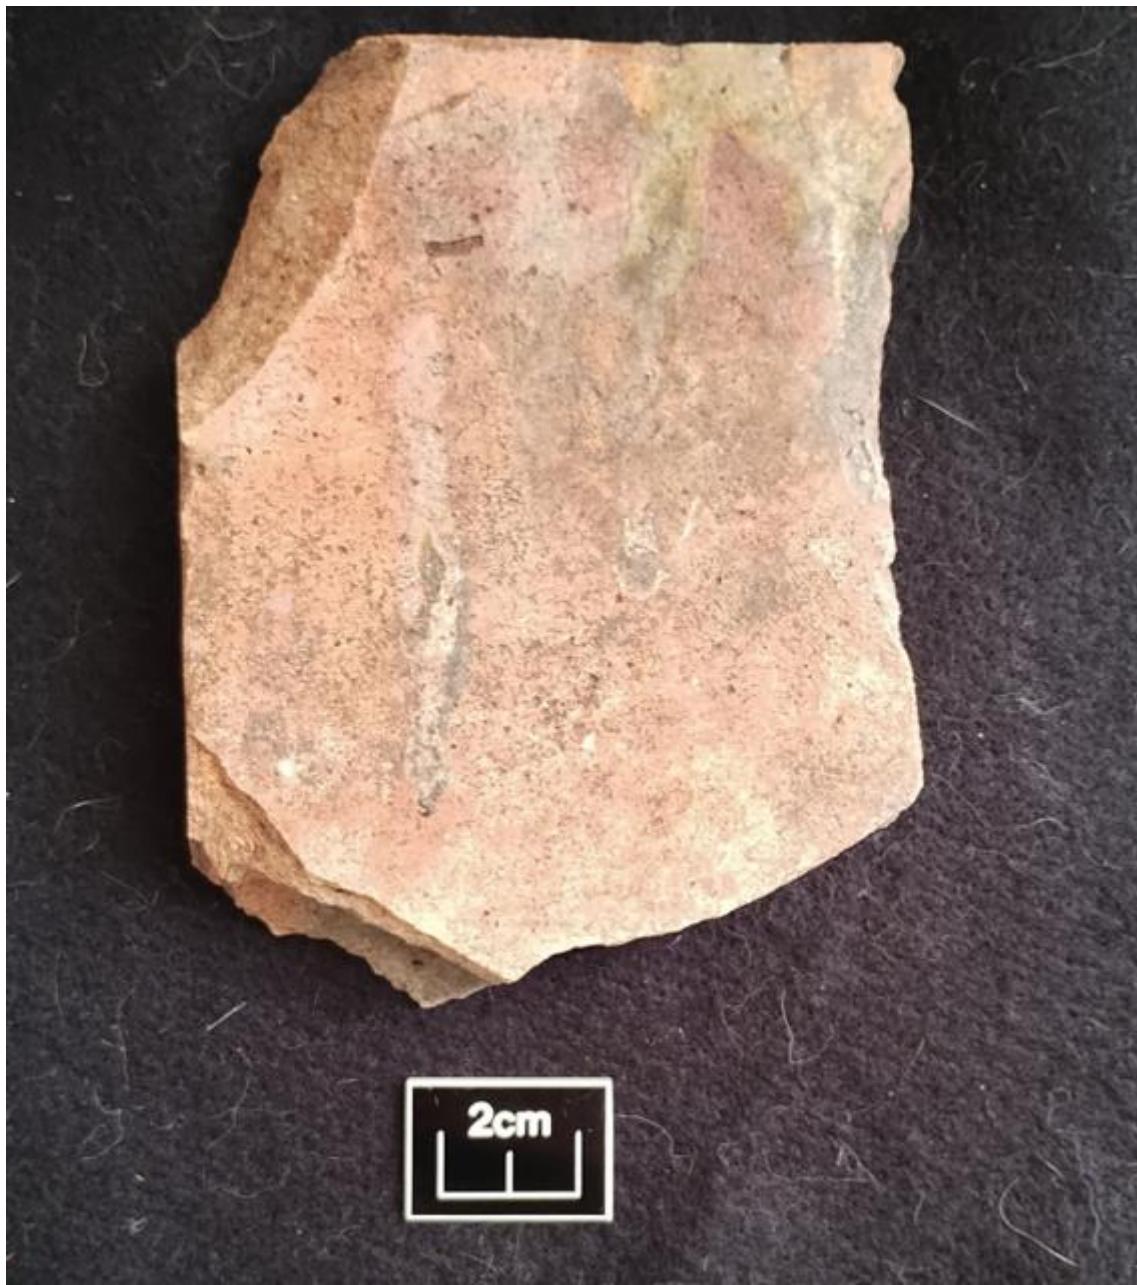
#### 8.4. T3 - Context 301 SF3 (Figure 22)

A corner from a fragment of 2cm thick Redware floor tile that measures 12cm by 10cm and has streaks of green glaze visible on one edge and one surface. The fabric of this tile has an oxidised surface and a reduced grey core, and it is a Scottish product.

Figure 22 - Trench 3 Context [301] SF3 Corner fragment from Scottish Redware floor tile. Image from D. Hall.

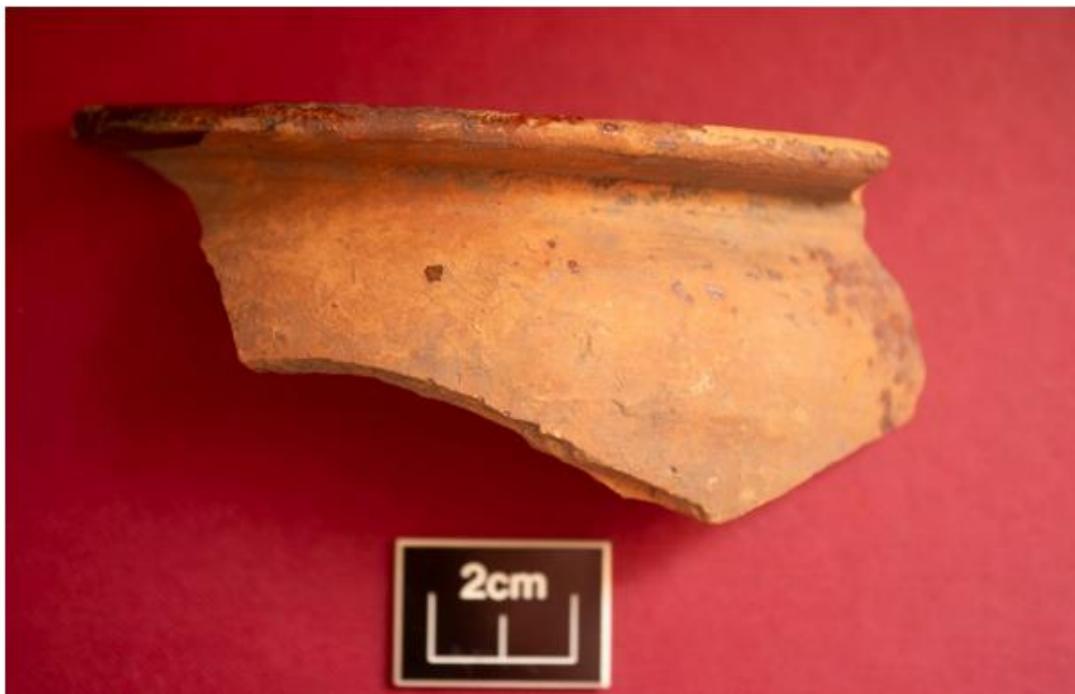
##### Context 801 SF1 (Figure 23)

A rim sherd in Scottish Post Medieval Oxidised Ware with an oxidised exterior surface, oxidised core and interior splash glazed green, brown. Vessels in Scottish Post-Medieval Oxidised and Reduced Wares (also known as Throsk-Type Wares) are mass-produced and represent a development in firing technology from the earlier Scottish Medieval Redwares (Caldwell and Dean 1992; Harrison 2002;

Haggarty, Hall and Chenery 2011, 13). This sherd is probably from a chamber pot and dates to the 16<sup>th</sup> / 17<sup>th</sup> centuries.

**Figure 23** - Trench 8 Context [801] SF1 Rim and sidewall possibly from a Scottish Post-Medieval Oxidised Ware chamber pot. Image from D. Hall.
