# **Stirling Burgh Wall Project, 2024**

## **Data Structure Report (Draft)**

# **Stirling Burgh Wall Project 2024**

## **Data Structure Report**

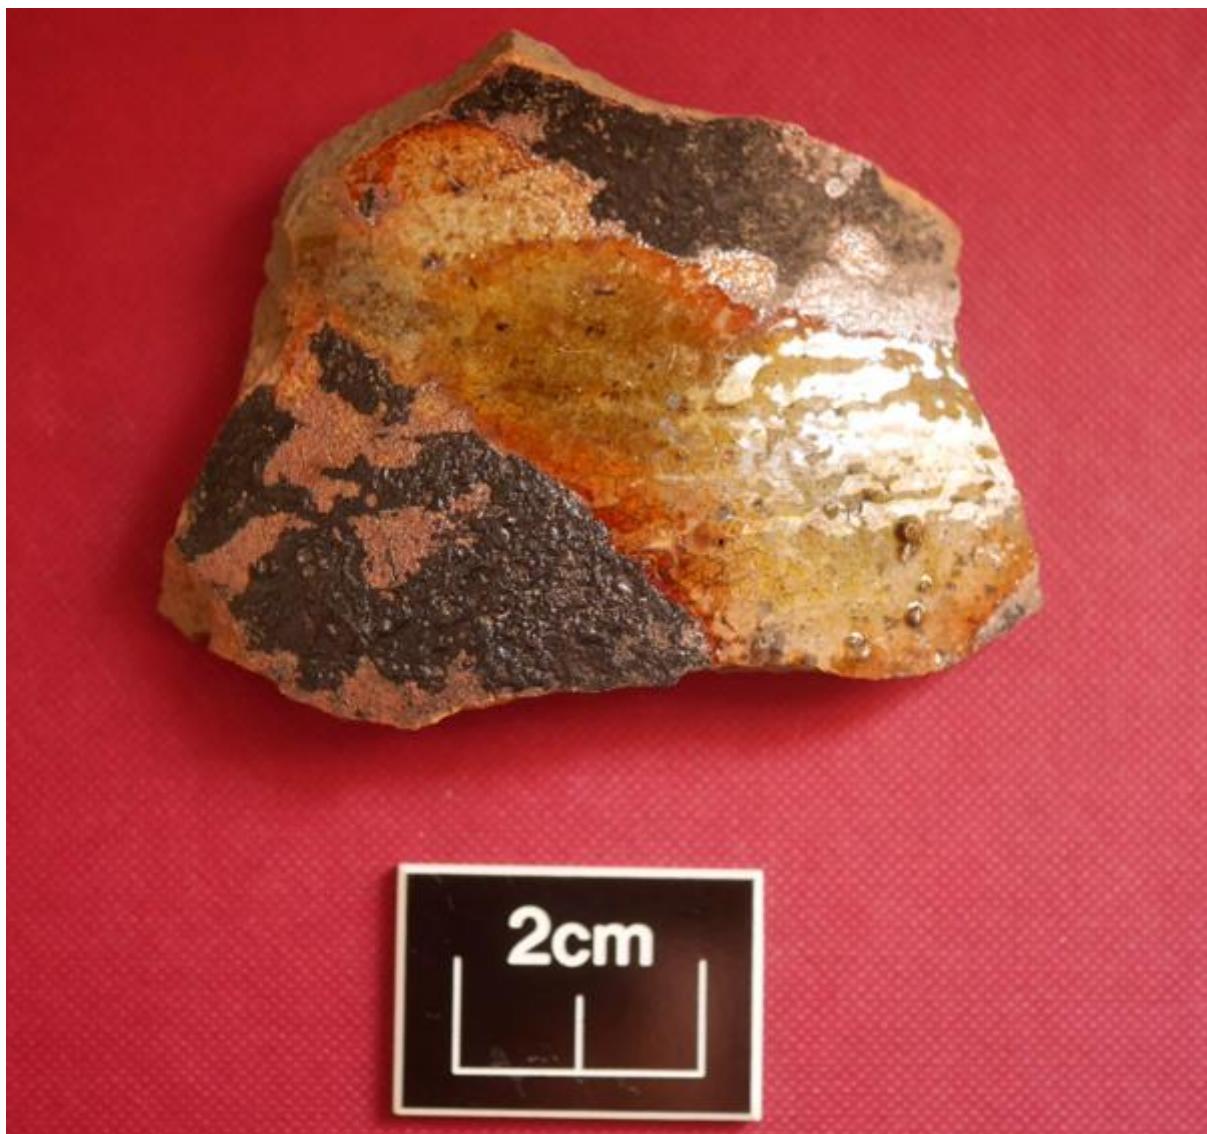
#### **8.9. Context 801 SF5 (Figure 24)**

A body sherd in Scottish Post Medieval Reduced Ware is internally glazed green with an external green glaze streak and a slightly carbonised deposit. This may be from a cooking vessel to the 16<sup>th</sup>/17<sup>th</sup> centuries.

**Figure 24** - Trench 8 Context [801] SF5 Bodysherd from a cooking vessel? in Scottish Post Medieval Oxidised Ware that is internally glazed green with an external green glaze streak and a carbonised deposit. Image from D. Hall.

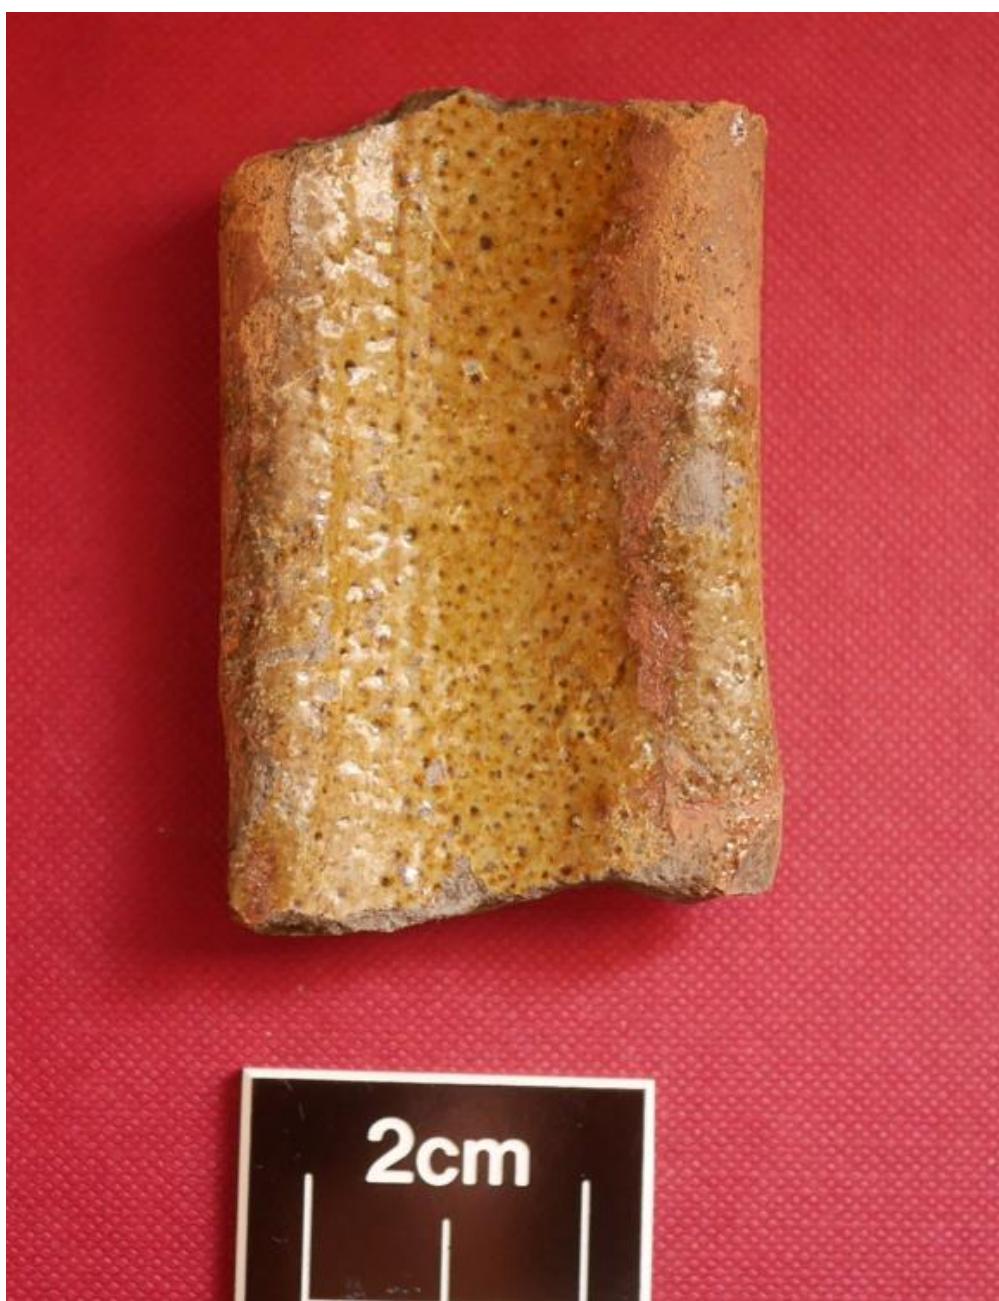
**8.15. Context 801 SF11 (Figure 25)**

A strap handle fragment in Scottish Post Medieval Reduced Ware splash glazed green internally with traces of a purple-brown heat skin on its external surface. This is probably from a jug and dates to the 16<sup>th</sup>/17<sup>th</sup> centuries.

**Figure 25** - Trench 8 Context [801] SF11 A strap handle fragment from Scottish Post Medieval Reduced Ware vessel splash glazed green internally and traces of a purple-brown heat skin on its external surface. Image from D. Hall.

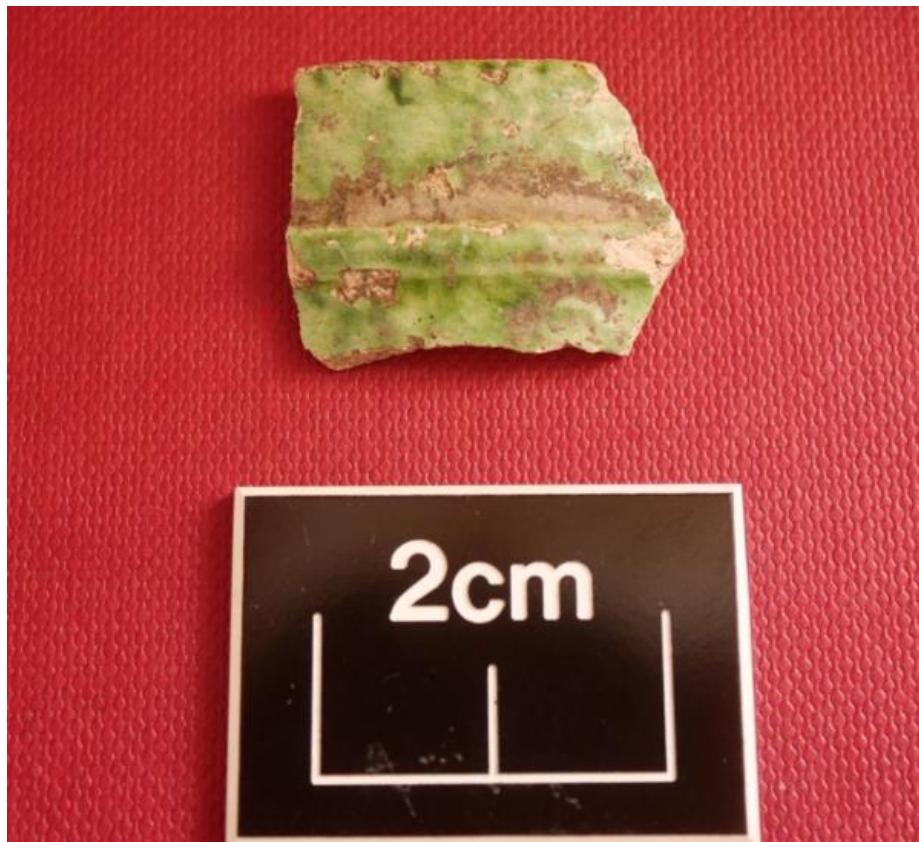
**8.22. Context 803 SF18 (Figure 26)**

A rim sherd from a fine green glazed Whiteware vessel with an external horizontal ridge. This is probably French and from a vessel in Beauvais Lead Glazed Earthenware (Haggarty 2006, File 26). It dates to the 16<sup>th</sup> and 17<sup>th</sup> centuries.

**Figure 26** - Trench 8 Context [803] SF18 Rimsherd from a fine green glazed Whiteware vessel. French probably Beauvais Lead Glazed Earthenware. Image from D. Hall.
